ENVIRONMENTAL MONITORING COMPONENT 2001

**NOAA/USAID Small-Scale Shrimp Producer Technical Assistance
Program for Nicaragua**

Environmental Monitoring Component

Final Report

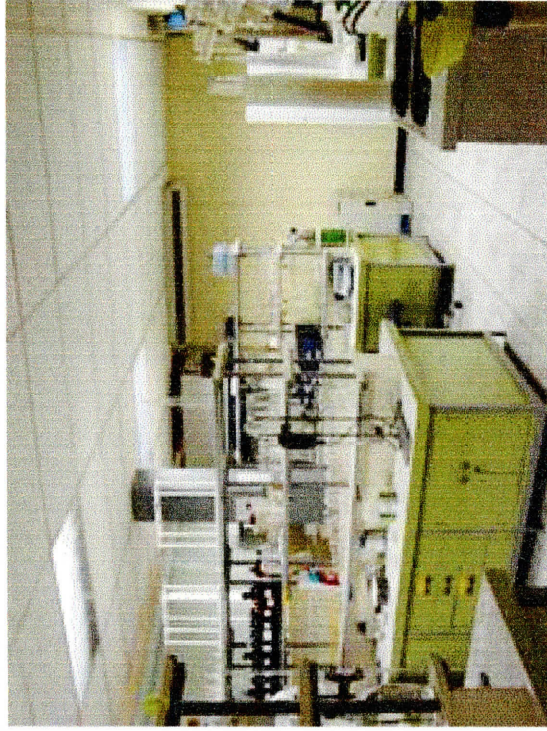
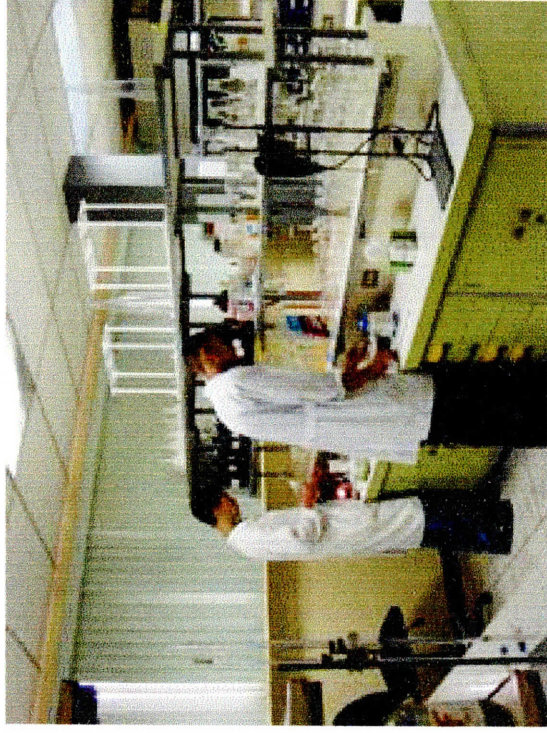
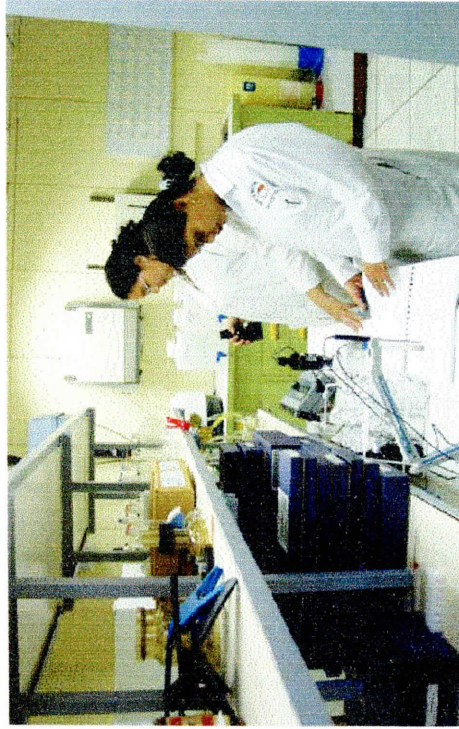
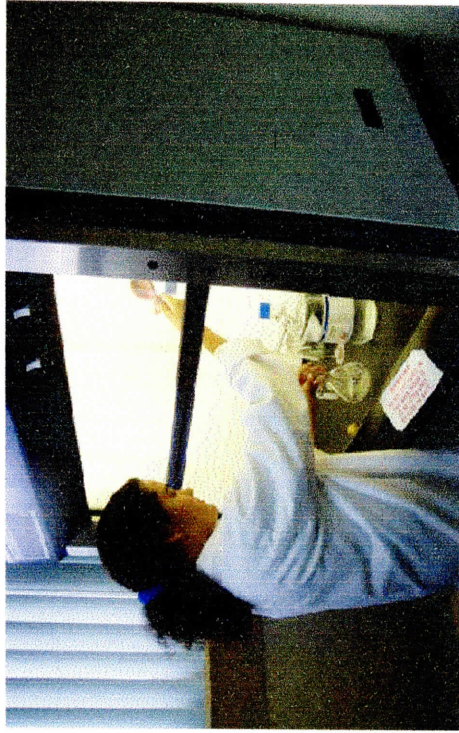
Figure 2. Water quality laboratory at the Centro de Investigación de Ecosistemas Acuáticos, Universidad Centroamericana.

The water quality laboratory at the UCA/CIDEA was up-graded as part of this project during May-June, and laboratory equipment and supplies were augmented (Figure 2). The laboratory equipment and supplies arrived in country in May 2001(see Appendix I). Nutrient analyses were performed on water samples from all sampling stations. Total alkalinity, total hardness, soluble reactive phosphorus, total suspended solids, sulfates, total ammonia nitrogen, nitrite, nitrate, 5-day biochemical oxygen demand (BOD₅), chlorophyll *a*, and settleable solids were determined according to methods given in Standard Methods (APHA, 1998). Total nitrogen and total phosphorus were analyzed according to the methodology of Grasshoff et al. (1983). Reactive silicate was determined according to the procedure given in Strickland and Parsons (1977).

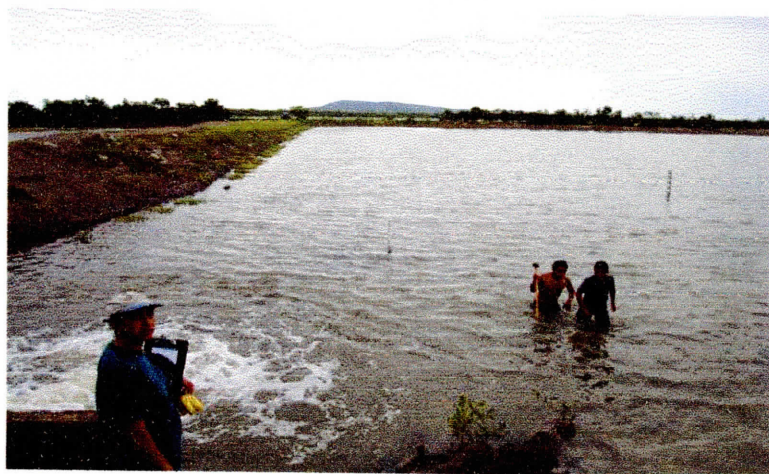
Figure 36. The Granja Edgar Lang 22-ha pond used for the nutrient budget study.

The Granja Edgar Lang (Figure 36) stocked one 22-ha pond for the nutrient budget study. Shrimp were stocked at 5.5 PL/m² for the 86-day grow out period (Table 24). Shrimp (*P. vannamei*) were fed limited amounts of commercial feed (25% crude protein; Table 25). Limited quantities of urea fertilizer were applied to ponds (Table 26). Limited water exchange was employed to maintain water quality.

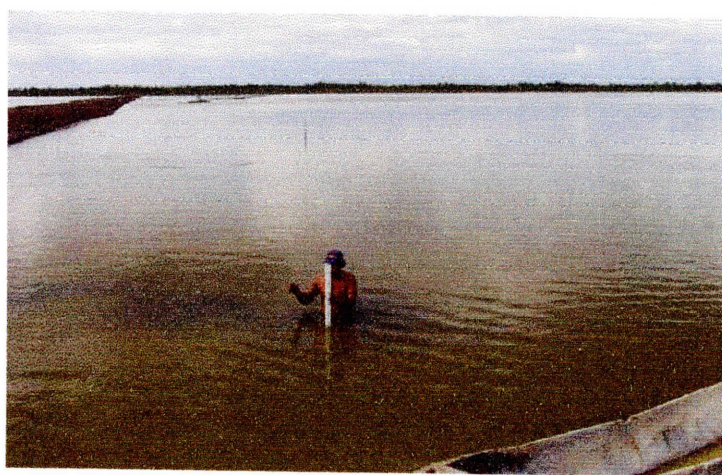
Figure 37. The Granja Rubén Darío 49-ha pond used for the nutrient budget study.

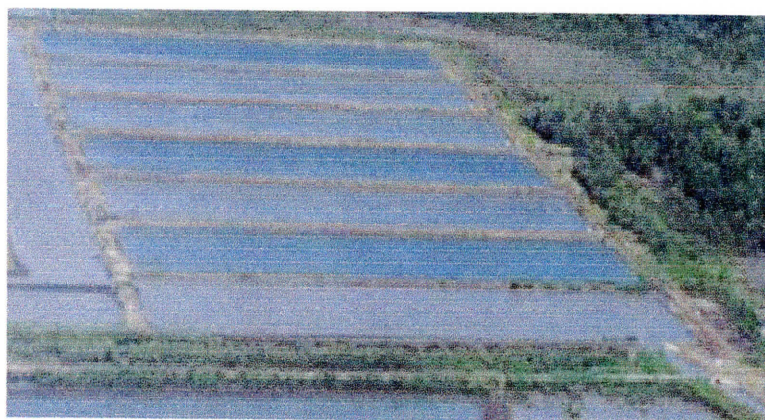
Figure 38. The UCA-CIDEA Demonstration Farm 1-ha ponds used in the nutrient budget study.

Three 1-ha ponds on the UCA-CIDEA Demonstration Farm (Figure 38) were used for the nutrient budget study. Shrimp (*P. vannamei*) were stocked in all ponds at 5.1 PL/m² and grown for 108 days (Table 24). Shrimp were fed a 25%-protein commercial feed (Table 25), and ponds were fertilized with two commercially available chemical fertilizers (Table 26). Water was added to ponds periodically only to replace losses to evaporation and seepage. No other water exchange was used.
